# INVESTIGATION BY THE ENTSO-E EXPERT GROUP INTO THE IBERIAN BLACKOUT OF 28 APRIL 2025

## Assessment of the investigation following the meeting on 15 July 2025

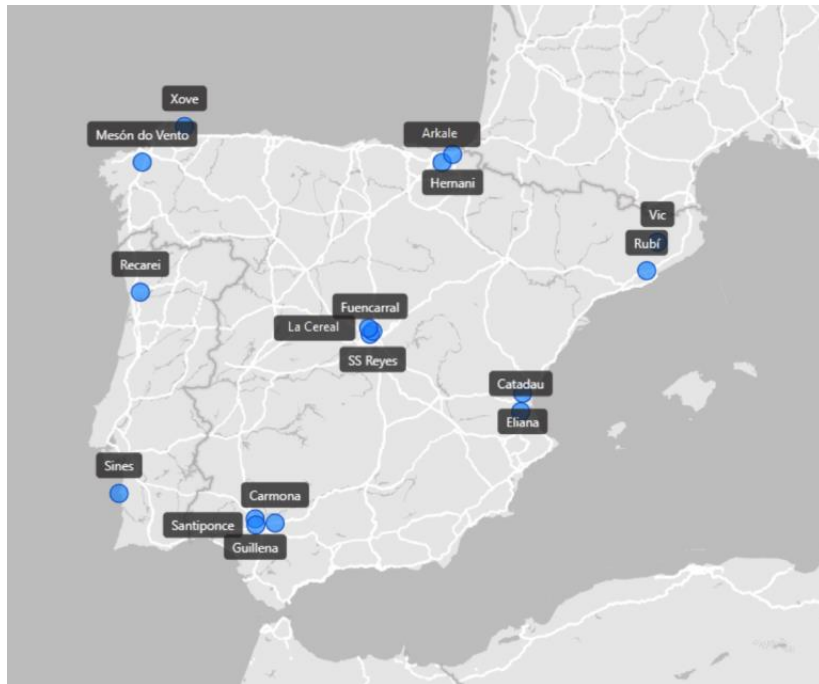
Figure 3 - Location of substations where voltage measurements were taken
