# INVESTIGATION BY THE ENTSO-E EXPERT GROUP INTO THE IBERIAN BLACKOUT OF 28 APRIL 2025

## Assessment of the investigation following the meeting on 23 June 2025

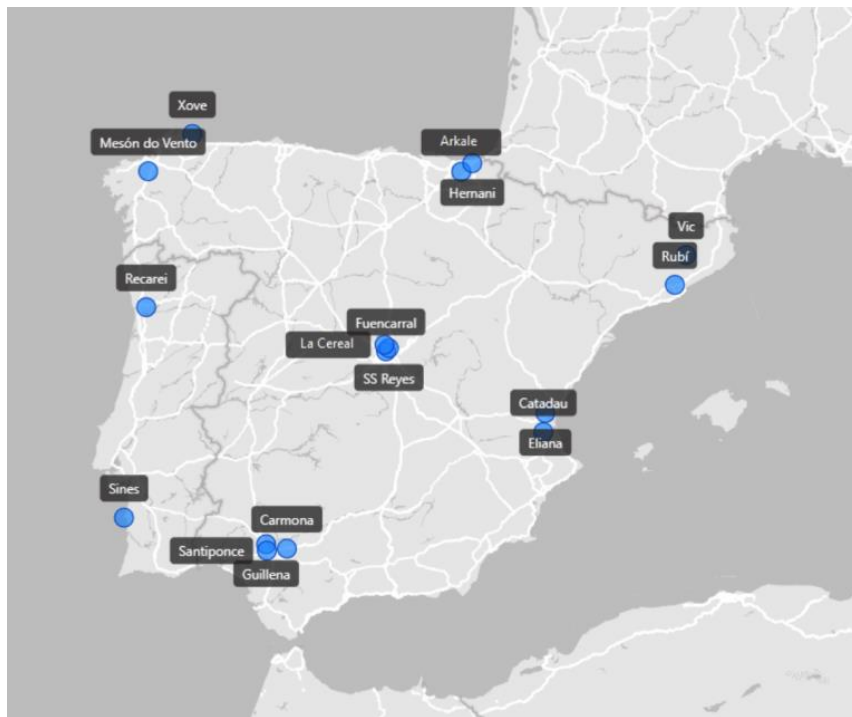
Figure 3 - Location of substations where voltage measurements were taken
