# INVESTIGATION BY THE ENTSO-E EXPERT GROUP INTO THE IBERIAN BLACKOUT OF 28 APRIL 2025

## Assessment of the investigation following the meeting on 15 July 2025

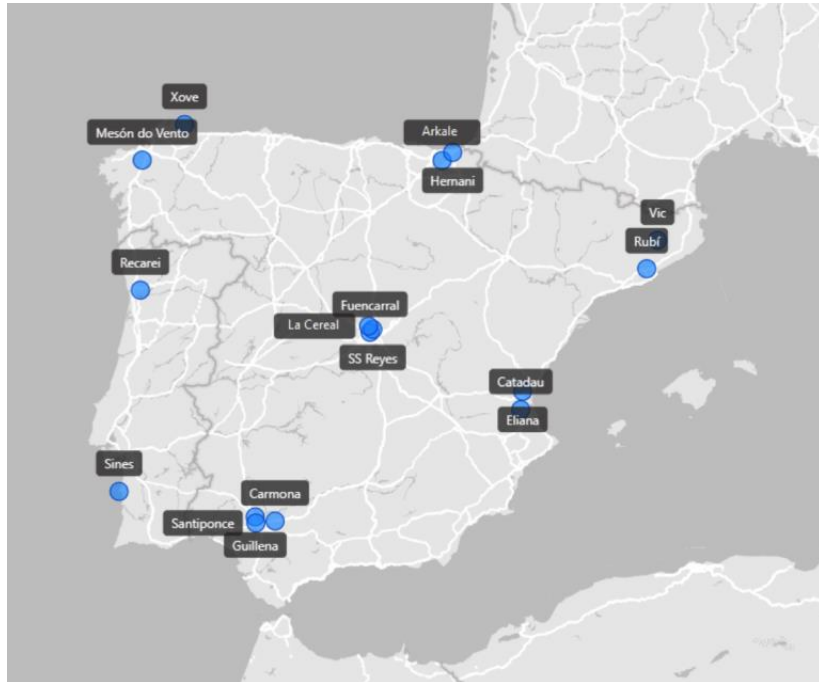
Figure 3 - Location of substations where voltage measurements were taken

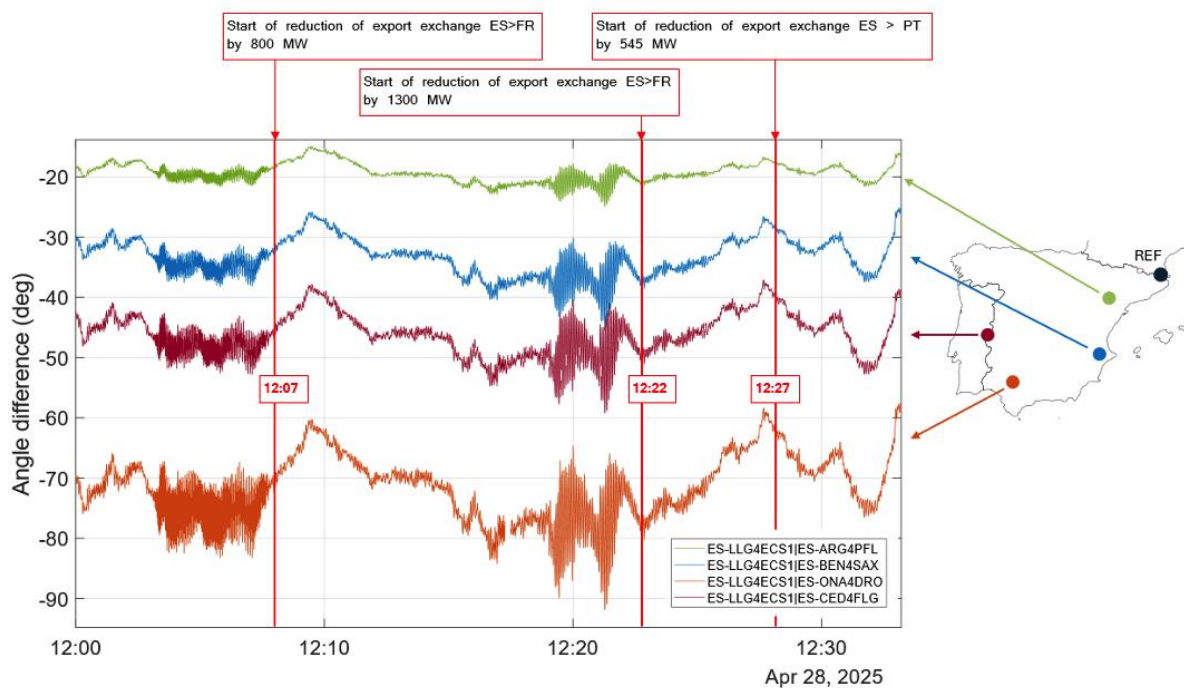
Figure 9 allows to visualize the evolution of the voltage angle difference at various locations of the Iberian system (compared to a reference location at border between France and Spain) after 12:00 CEST. The global effect of the applied countermeasures after the first oscillations is visible at 12:10 CEST, when the angles between different locations in Spain were significantly reduced; the unavoidable effect in closing the lines was an increase of injected reactive power into the system, and so an increase of voltages.

After this first action, the voltage angles of the system at 12:15 CEST came back to the values before the first oscillation due to an increase of exchanges between Spain and France, invalidating the previous countertrading action. The angle increase again created the conditions for the second oscillation.

Figure 9 - Evolution of the voltage angle difference after 12:00 CEST, and the effect of countermeasures, at 4 locations on the Iberian Peninsula (source: data from Red Eléctrica's PMU)

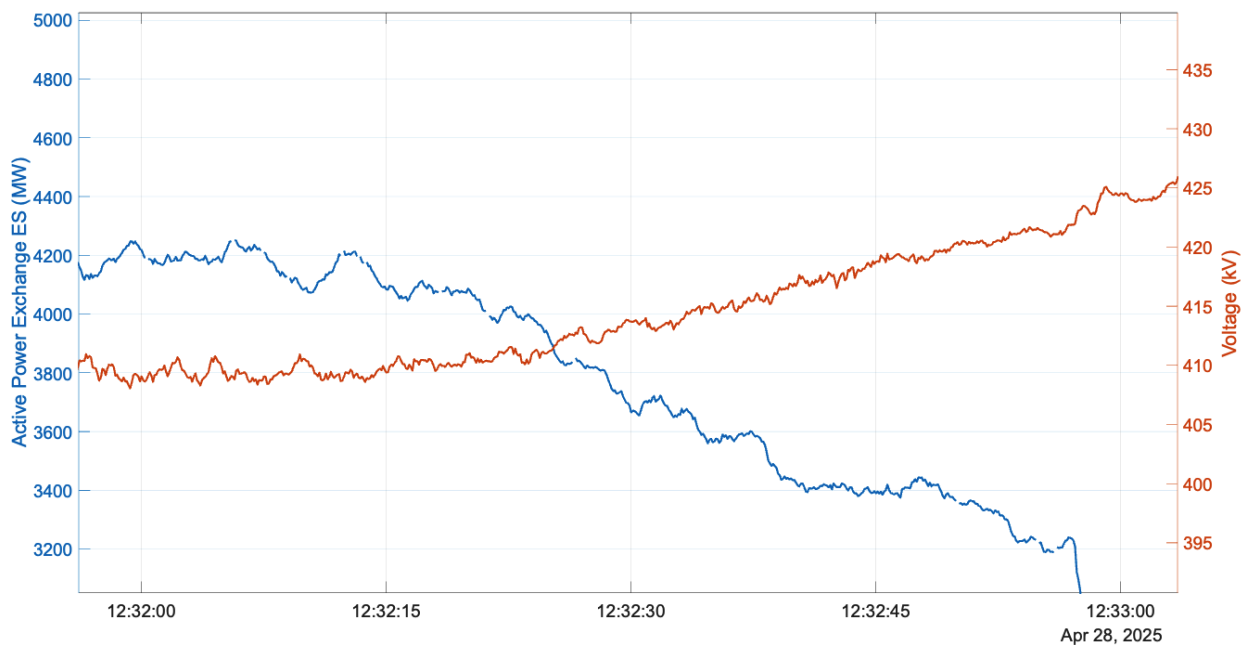
The figure below shows the evolution of the voltage and of the net active power exchange position of Spain starting from 12.32 CEST. It indicates that, around the time when the net active power exchange position of Spain began to decrease, the voltage started to rise.

The Expert Panel is examining if and to what extent the rise in voltage is related to the following possible causes, all associated with an increase in reactive power:

- the reduction of reactive power absorption by generators which decreased their active power operating with a fixed power factor, and/or
- the reduction of reactive power absorption by the transmission lines, associated to their loading, and/or
- increased reactive power injection from distribution systems. This potential correlation could have been exacerbated by the fact that the reduction of active power (and hence of reactive power absorption) took place mainly in the southern part of the system, leading to a longer low-loaded transmission path of the export towards France.

Figure 11: Voltage evolution at the Carmona substation and Spain's net active power exchange position in the minute before the blackout (source: Red Eléctrica PMU data)
